**Tree Report**  
**329, 341, 353 Page Street**

July 27, 2017

329, 341, and 353 Page Street  
San Jose CA

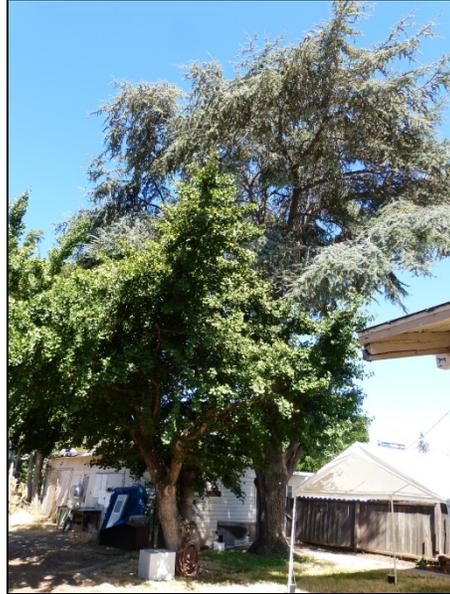
- Lemon bottlebrush #70 and 71 were in front of the home at 329 Page Street. Both trees were mature in development. Both were within 1' of the house foundation. Tree #70 was 13" and in fair condition while #71 was 10" and in poor condition.
- Ginkgo #72 was in the rear yard of 329 Page Street (Photo 1). This 24" tree was in poor condition due to a history of topping and crown reduction pruning. Several sets of codominant attachments were present.

**Photo 1.** Ginkgo #72 (foreground) and blue Atlas cedar (#73). Note small overall size of ginkgo and flat-topped form of the cedar.

- Blue Atlas cedar #73 was also in the rear yard of 329 Page Street (Photo 1). The tree was mature in development, 30" in diameter and in fair condition. Large branches had been stubbed back.
- Avocado #82 was a small tree in front of 341 Page St. Trunk diameter was 4'. Condition was good.
- Orange #83 was also in front of 341 Page Street. It was a large shrub in good condition.
- Lemon #84 was in the rear yard of 341 Page Street. It was also a large shrub but in poor condition.
- Calif. pepper #85 was in the front yard of 353 Page St. (Photo 2). This mature tree was 24" in diameter and in good condition. The crown was somewhat vase-shaped.

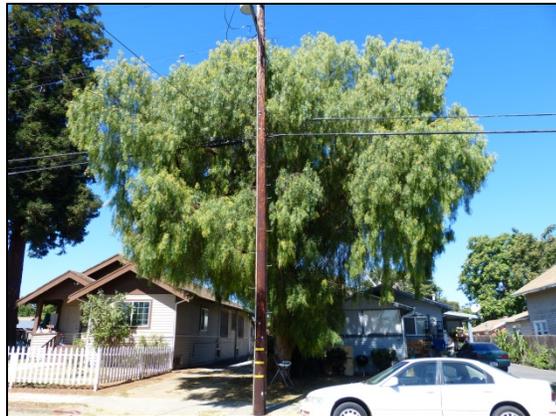
**Photo 2.** Looking across Page St. at Calif. pepper #85.

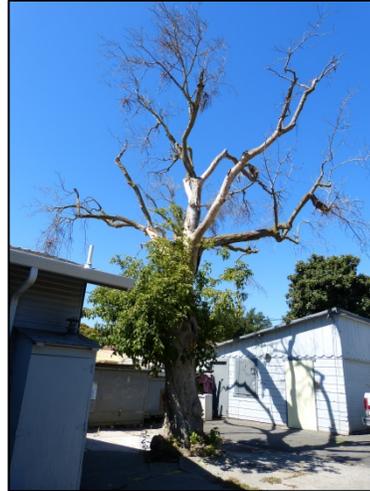
**Photo 3.** Boxelder #87.

- Boxelder #87 was 30" and largely dead (Photo 3). Only a few small sprouts were present.
